**MASSACHUSETTS COASTAL BASIN  
GLOUCESTER, MASSACHUSETTS**

**WEST POND OUTLET  
MA 00186**

# **PHASE I INSPECTION REPORT NATIONAL DAM INSPECTION PROGRAM**

**DECEMBER 1979**

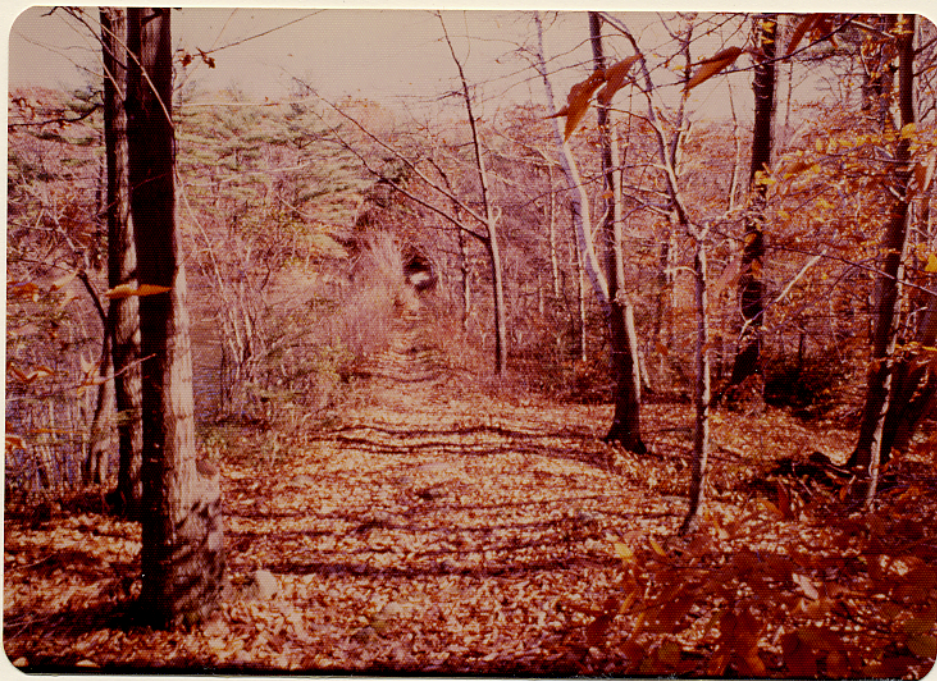
- b. Dam. West Pond Outlet is a earthfill dam with a stone masonry core wall. It was found to be in poor condition, a condition that has been prevalent since the first recorded inspection in 1912. The top of the dam is extremely narrow and footpaths have been heavily worn on the crest. In one place erosion of the top has occurred indicating the dam has been overtopped (see photographs 3 and 4 in Appendix C). The upstream slope is nearly vertical and the downstream slope is steep (1-1/2:1 horizontal to vertical). The upstream slope has been eroded exposing the core wall. Considerable sloughing was noted on both slopes. The riprap on the upstream slope has been eroded. Past inspection reports state that the riprap formerly on the upstream slope began to slide into the pond in 1938. Both slopes are covered with a thick growth of brush and trees (see photographs 1 and 2 in Appendix C).

**NO. 1 VIEW EASTWARD ALONG TOP OF DAM**

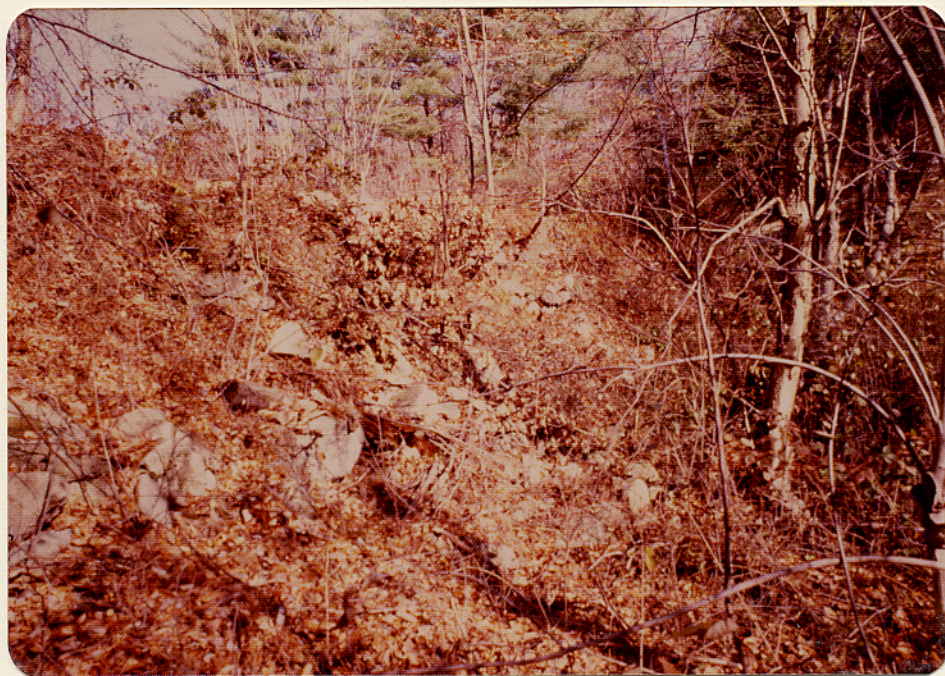
**NO. 2 DOWNSTREAM SLOPE OF DAM**

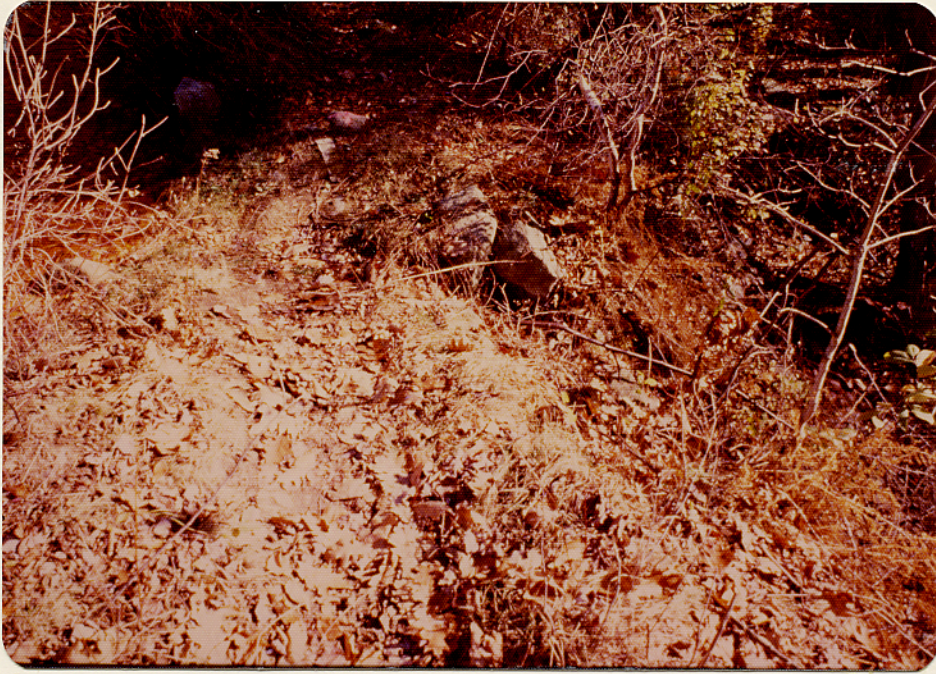
**NO. 3 AREA OF OVERTOPPING ON TOP OF DAM**

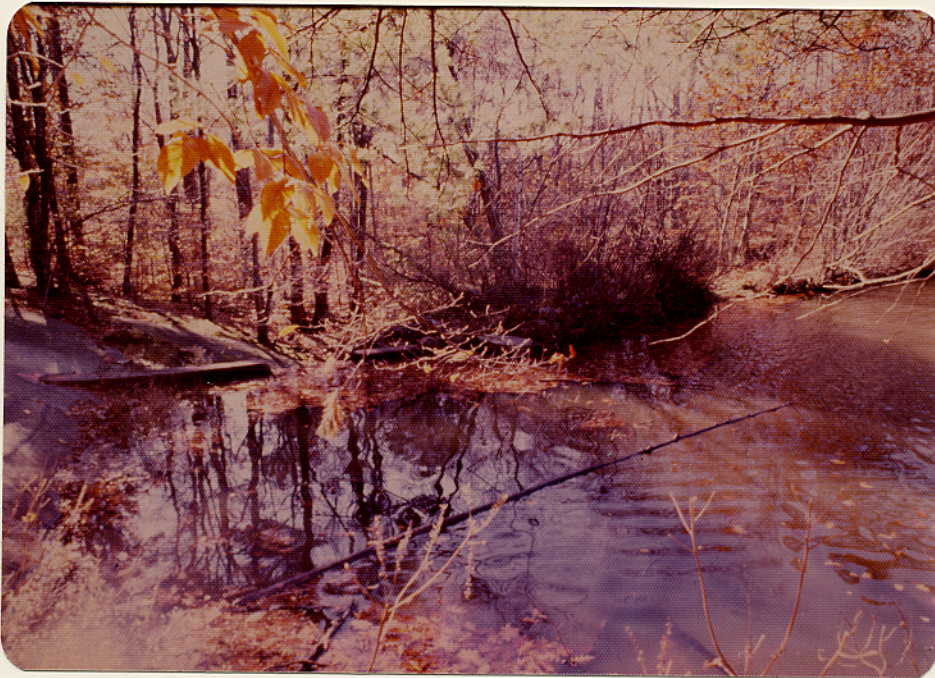
**NO. 4 UPSTREAM VIEW OF SPILLWAY AND LOW SPOT ON TOP**

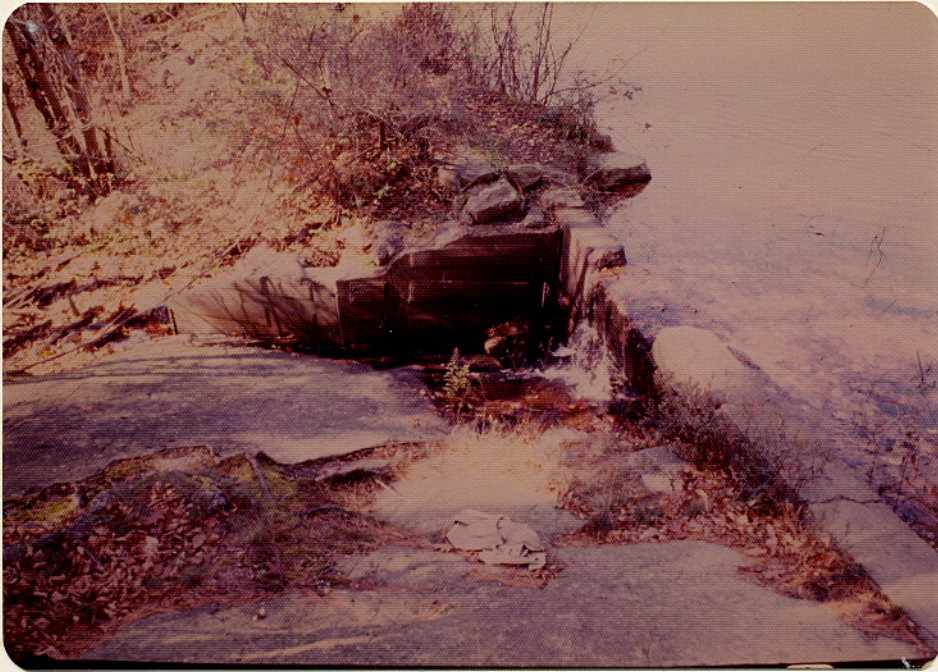
The abutments tie into natural ground. There is an outcrop of bedrock at the east abutment which forms the foundation of the spillway (see photographs 5 and 6 in Appendix C).

spillway. A rectangular notch, centrally located in the spillway, is 4.0 feet long, 0.3 feet deep and is at El 72.6. The crest of the main weir is at El 72.9. The spillway is constructed of mortared stone capped with concrete and is generally in poor condition. The mortar and stone are cracked, spalled, stained, and partially eroded. The spillway and training wall have separated and water is flowing through the separation (see photograph 7 in Appendix C). Water is also seeping through the spillway stonework. The eastern end of the spillway is founded on a rock outcrop, and water is flowing between the concrete and the rock (see photograph 6 in Appendix C). The outcrop serves as the floor of the spillway as well as the eastern training wall (see photograph 5 in Appendix C). The training wall on the western side of the spillway is constructed of concrete and tapers from a height of 2 feet at the weir to ground level approximately 15 feet downstream.

**NO. 5 VIEW OF SPILLWAY**

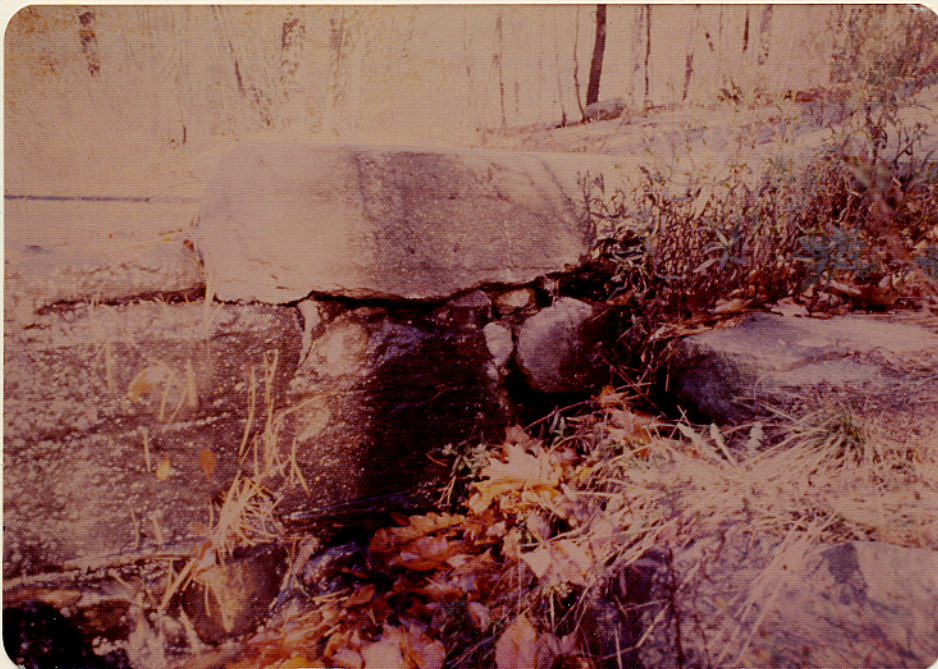
**NO. 6 EAST ABUTMENT OF SPILLWAY**

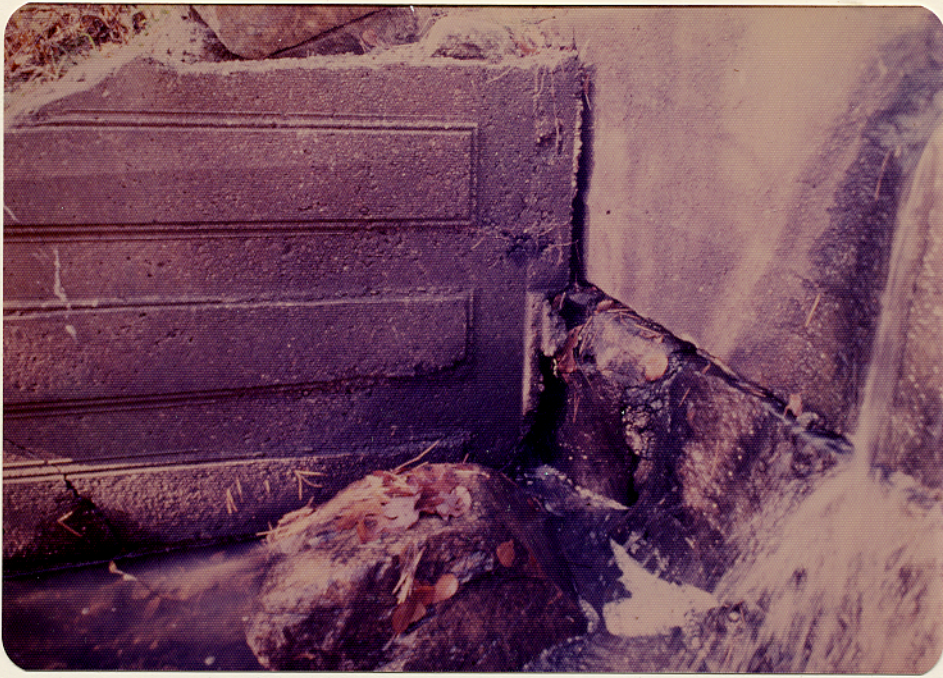
b. Weir and Training Walls	Flat crested
General Condition of Concrete	Generally poor, concrete weir on top of mortared stone, heavily cracked top deteriorated and eroded, separation at training walls from spillway
Rust or Staining	d/s face of weir at right training wall
Spalling	Evident throughout
Any Visible Reinforcing	None visible
Any Seepage or Efflorescence	3-5 gpm estimated flowing through at base of spillway weir
Drain Holes	None visible

**NO. 7 WEST ABUTMENT AND TRAINING WALL OF SPILLWAY**

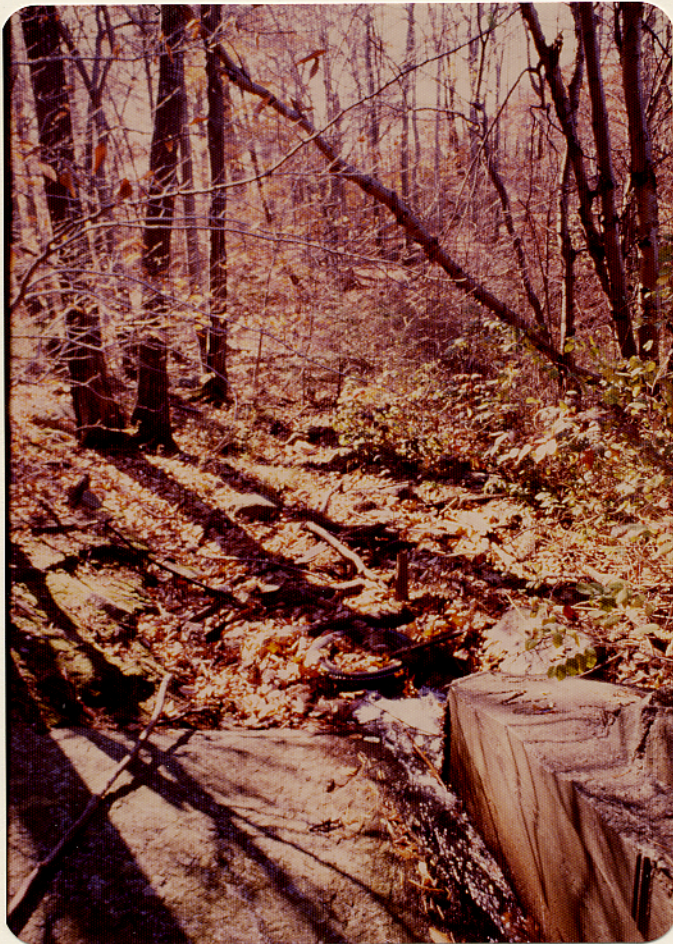
c. Discharge Channel	
General Condition	Very poor; rock, timber, debris throughout
Loose Rock Overhanging Channel	Some
Trees Overhanging Channel	downed trees
Floor of Channel	ledge for 25 ft., then soil covered with heavy vegetation
Other Obstructions	Partially blocked culvert d/s at Hesperus Avenue

**NO. 8 DOWNSTREAM DISCHARGE CHANNEL**
